ADF&G TECHNICAL DATA REPORT NO. 106  
(Limited Distribution)

## REVISED ANADROMOUS STREAM CATALOG OF SOUTHEASTERN ALASKA

District 106

North Prince of Wales Island

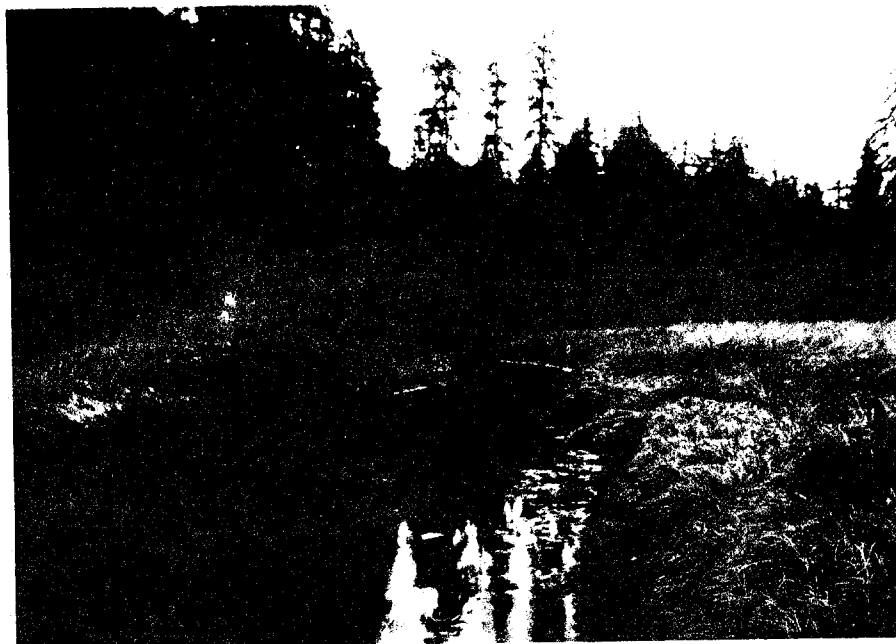
1. Lower ITZ Viewed From Confluence With ITZ of Little Creek.

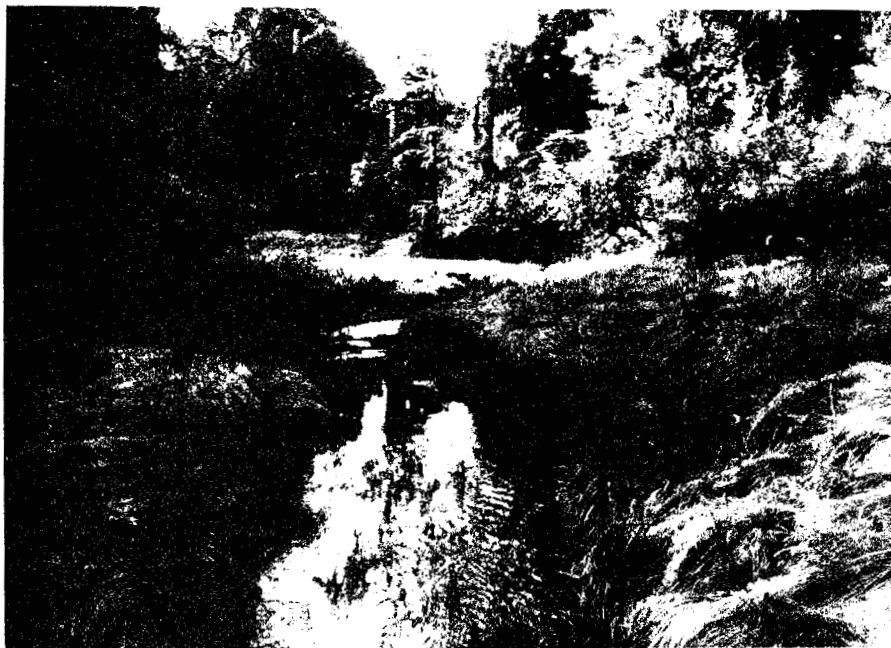
3. Upper ITZ and Mouth With Grass in Substrate.

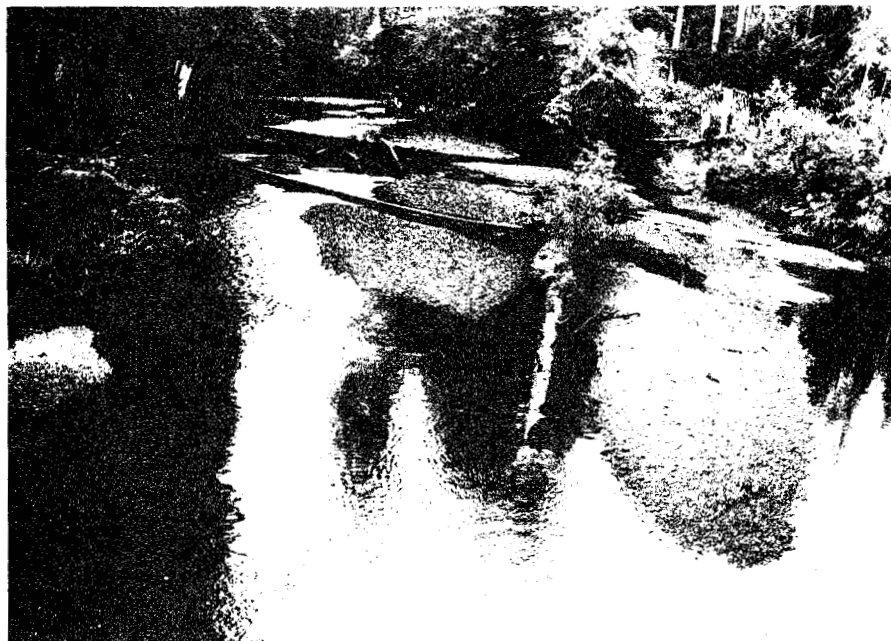
4. Big Creek. Pool/Riffle Area Above Bridge.

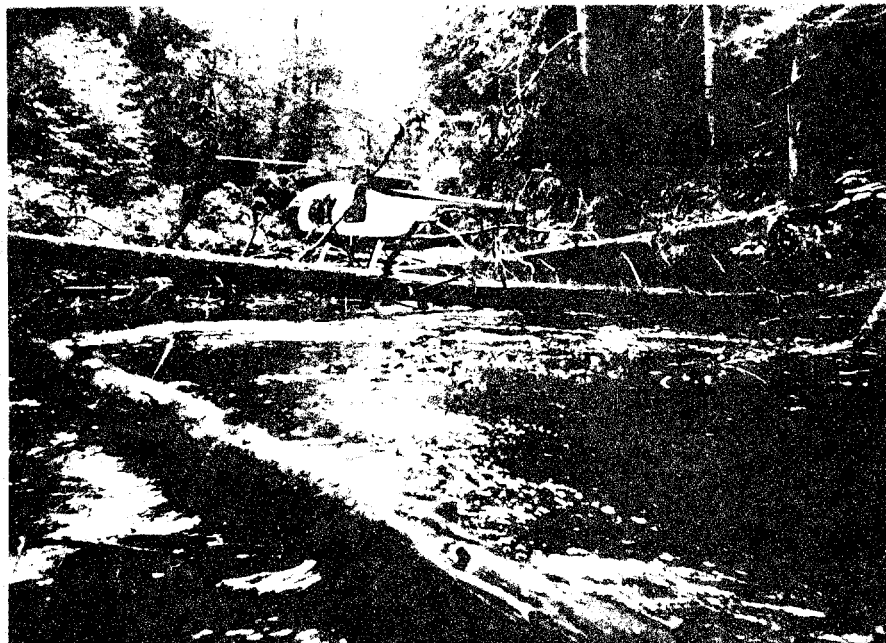
6. Section 17: Cobble riffles and Blowdown Induced Debris Provide Isolated Spawning and Moderate to Excellent Rearing.

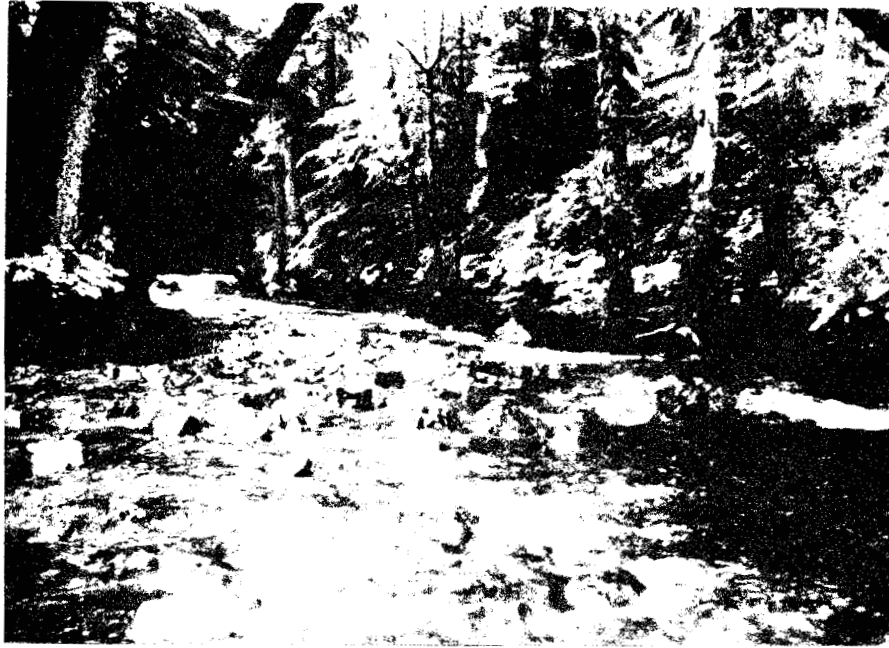
11. Downstream View of Section 35. Channelized Stream Flow Through Steep Banks Over Cobble/Boulder Substrate.

Section 35: 10-32m; Right bank failure 22m long by about 3m high; and several "leaning" trees which will be in the channel soon. Failure is due to the undermining of the banks by the stream and to a thin soil layer over large cobble/boulders.  
73m; Side channel diverges.  
98m; A 7m wide channel converges on right with gravel/small cobble substrate.

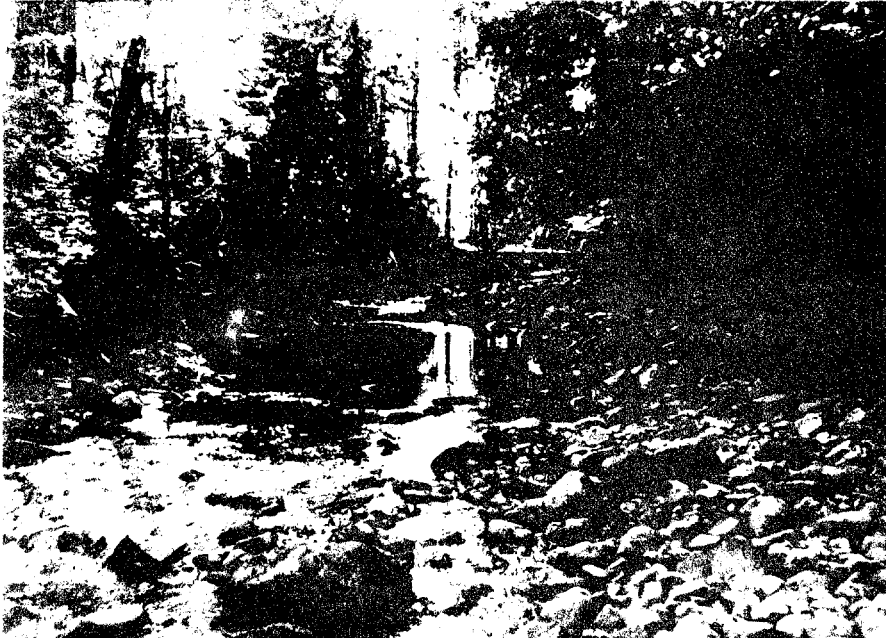
1. Section 1: Typical Stream Habitat of Bedrock/  
Cobble Substrate.

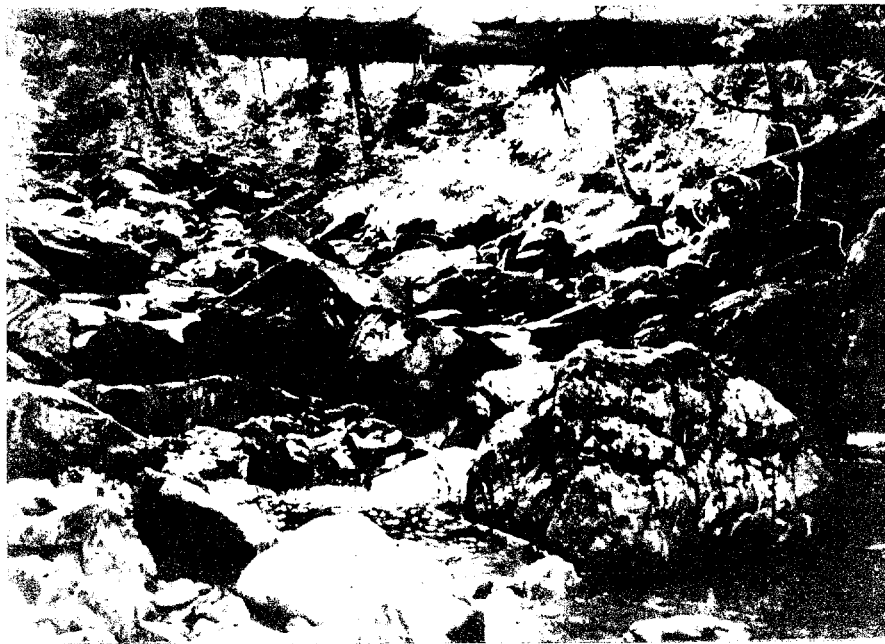
2. Survey Area D; Section 3: Bedrock/Boulder Cascades are the Predominant Habitat Association.

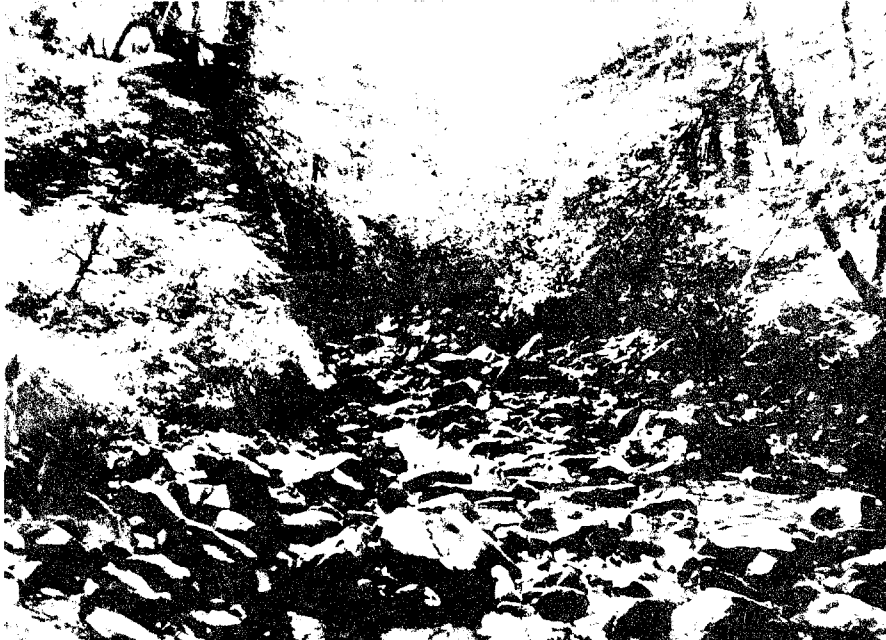
1. Section 1: 30m; A Bedrock/Cobble Strewn Channel Typifies "Available Habitat".

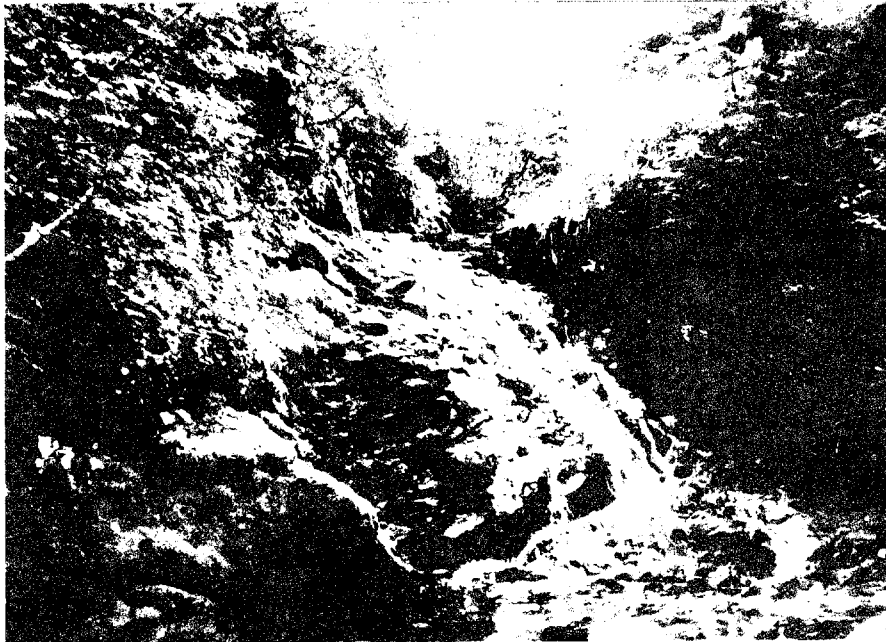
2. Section 5: 27.5m; 3.0 Vertical Meter Barrier Falls Demarcates Survey End.

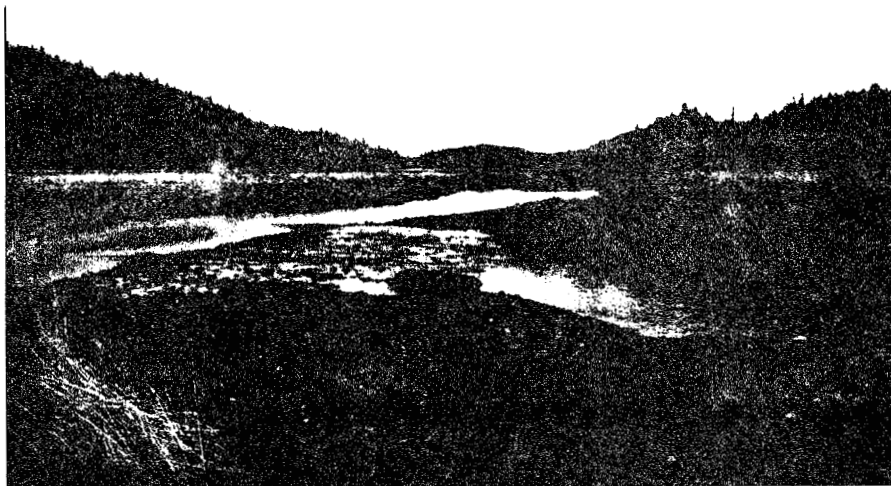
1. Downstream View of Lower ITZ and Confluence with ITZ of Big Creek Looking Toward Red Bay.

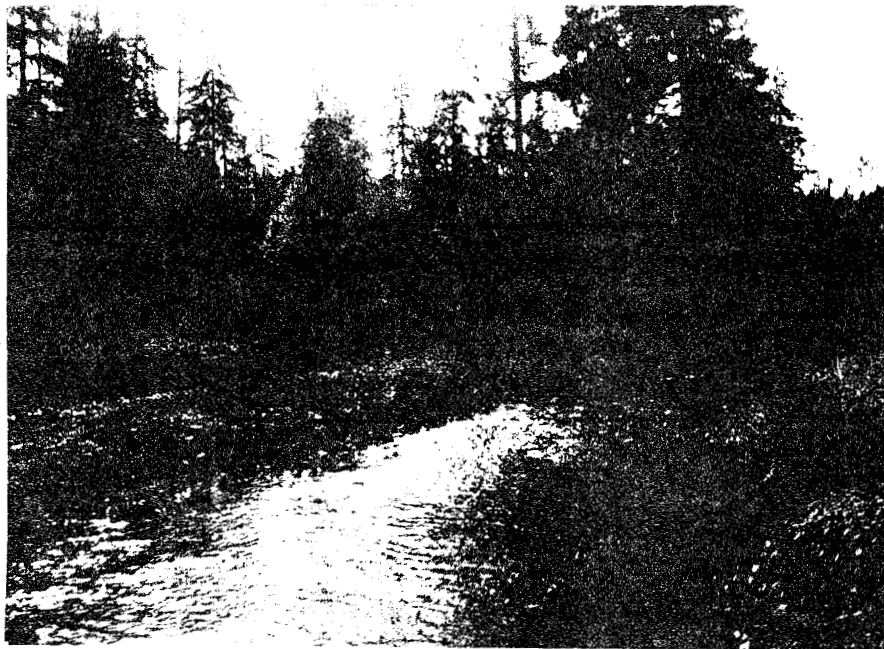
2. Upper ITZ and Mouth With Windthrown Buffer Strip, Right Side.

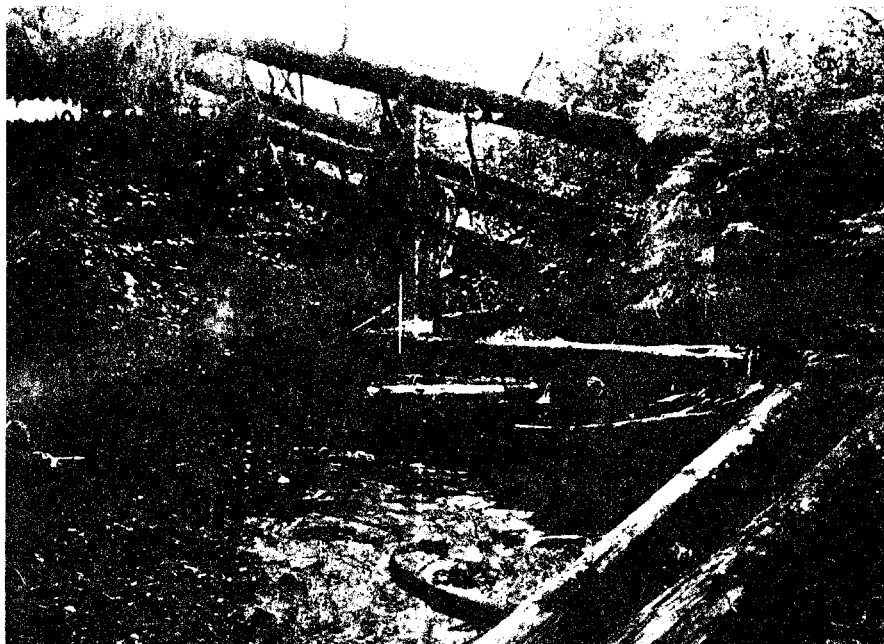
5. Section 2: Heavy Instream Debris with Windthrow.

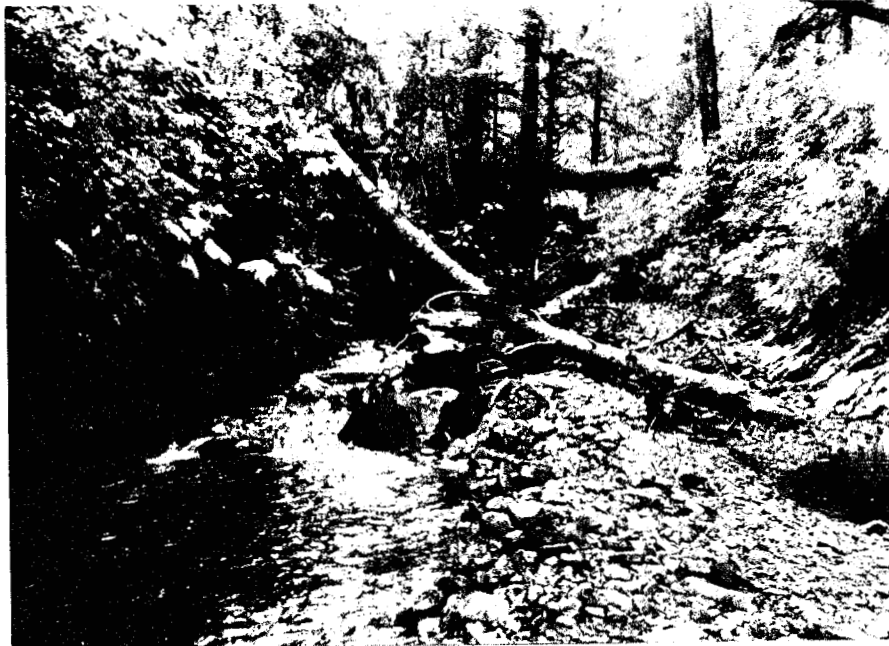
7. V-notch Habitat Above Bridge and Below Falls,  
Section 10: 0m.

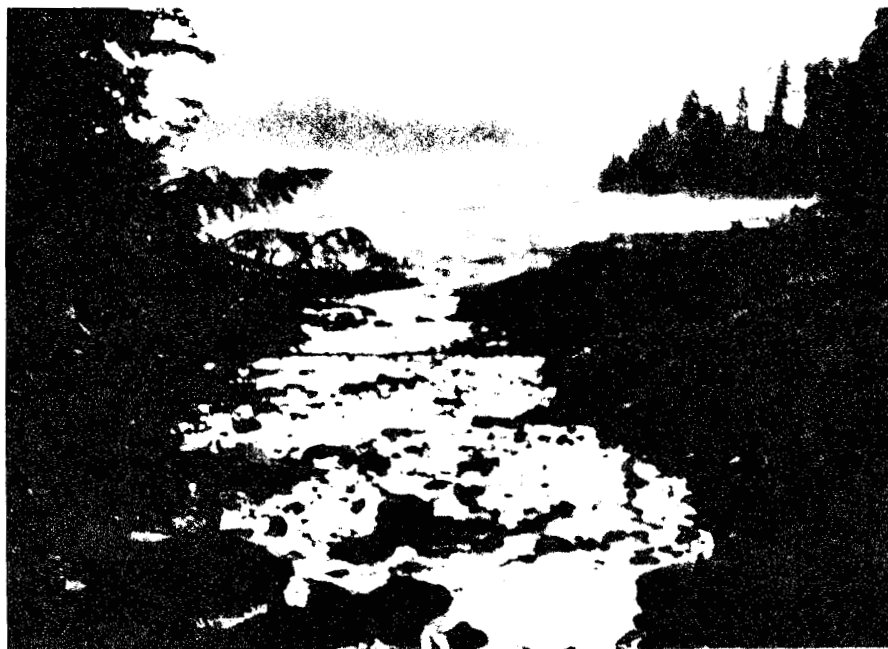
1. Intertidal Zone Looking Downstream Into Red Bay.

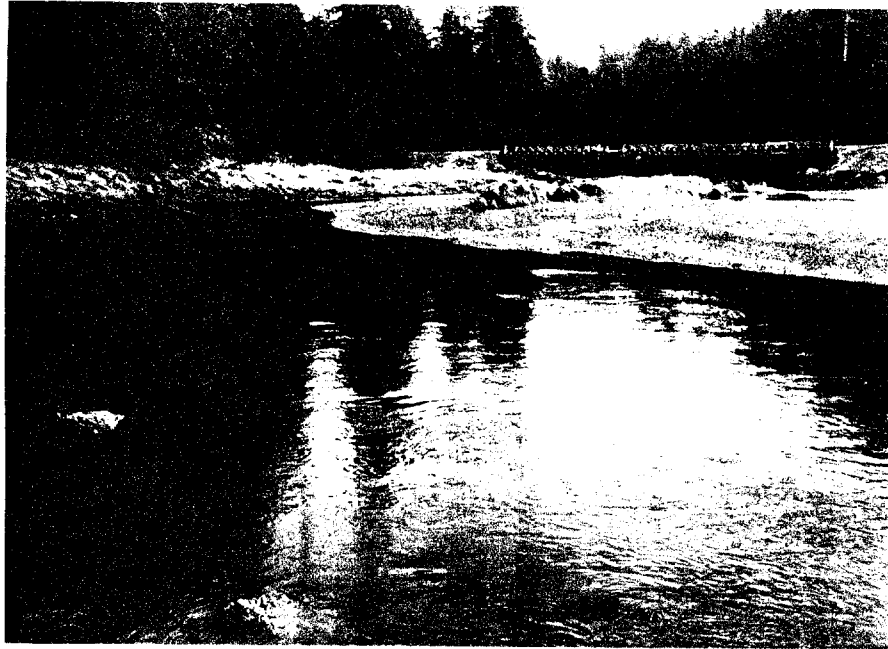
1. The ITZ looking upstream along the main channel to the road crossing. Intertidal ASA is fair but spotty due to large cobble and boulders.

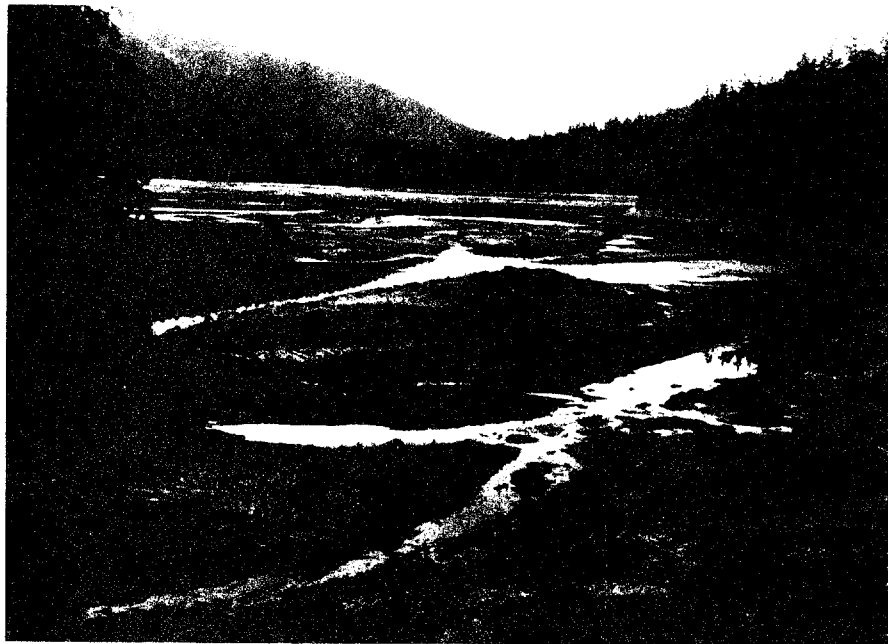
2. The ITZ is quite braided through the mud flat below the bridge.

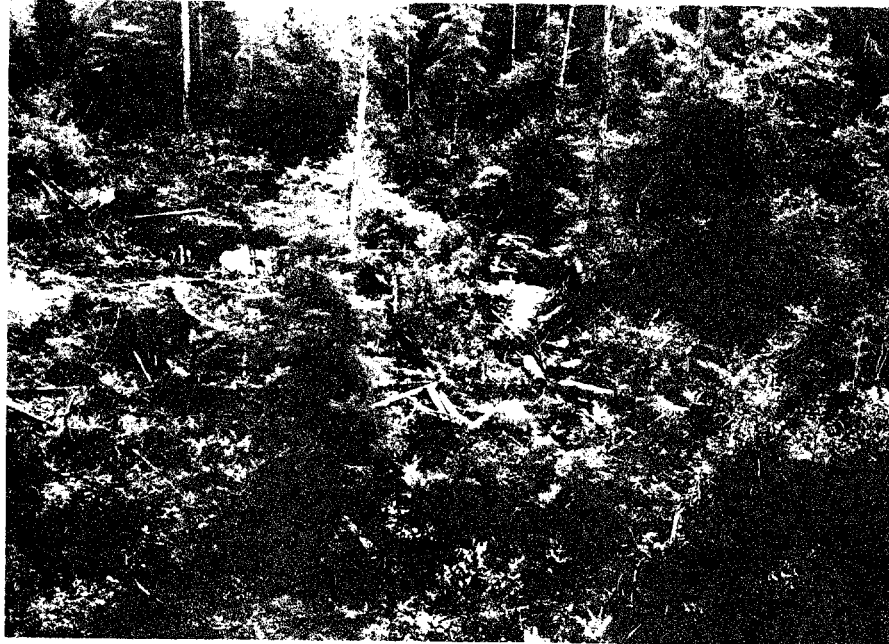
2. Area "B": Section 16: Clearcut unit extends to the left bank. Copious debris and beaver activity has induced channel migration.

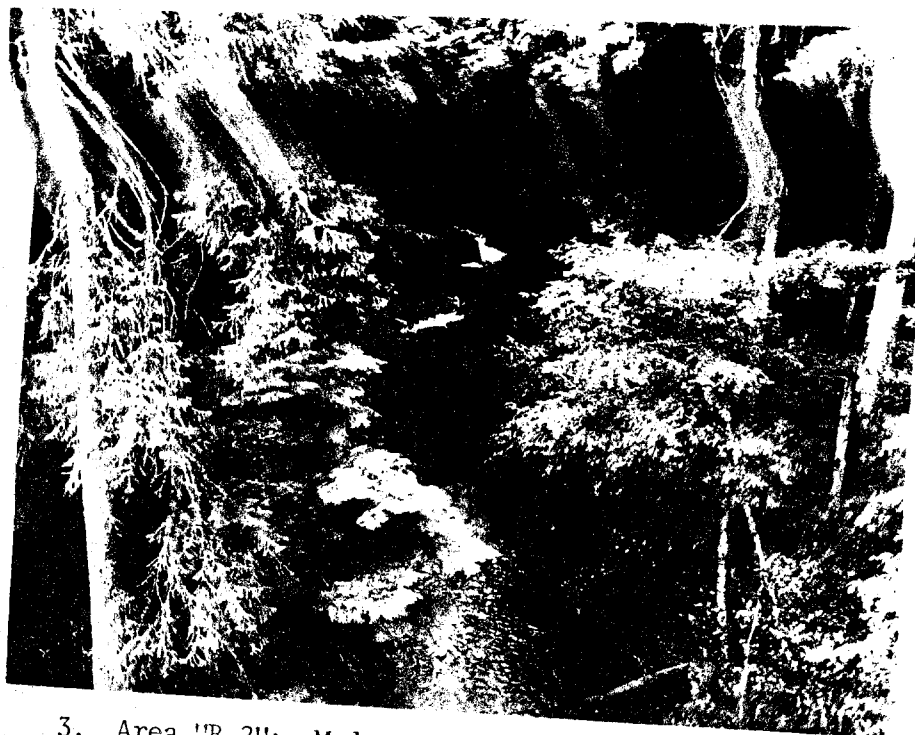
3. Area "B-2": Moderate gradient and coarse substrate culminate in several sets of bedrock cascades. Rearing SS fry were observed in peripheral pools throughout the survey area.

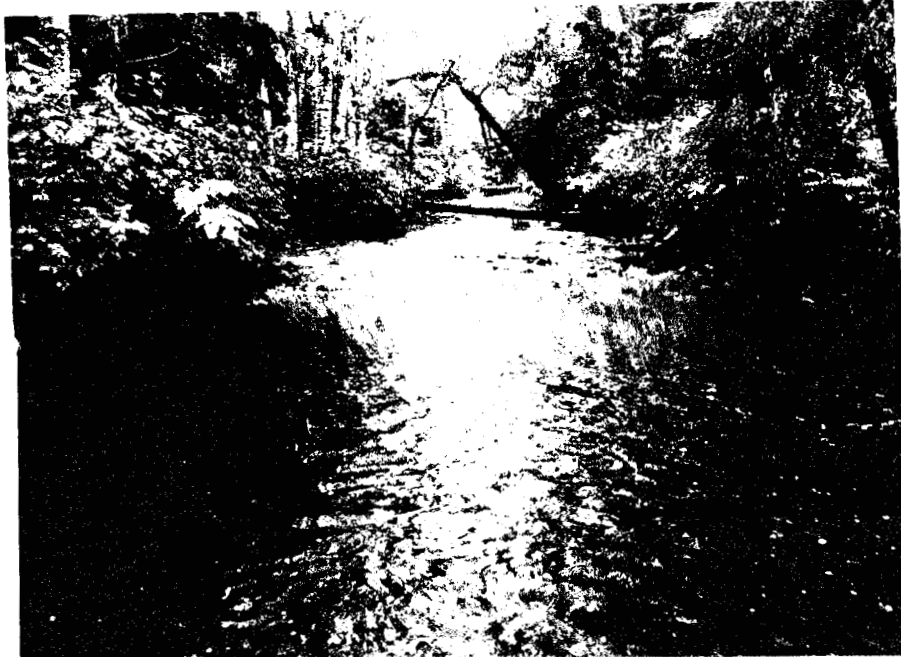
5. Area "B-3": Moderate gradient and a primarily cobble substrate provide limited ASA.

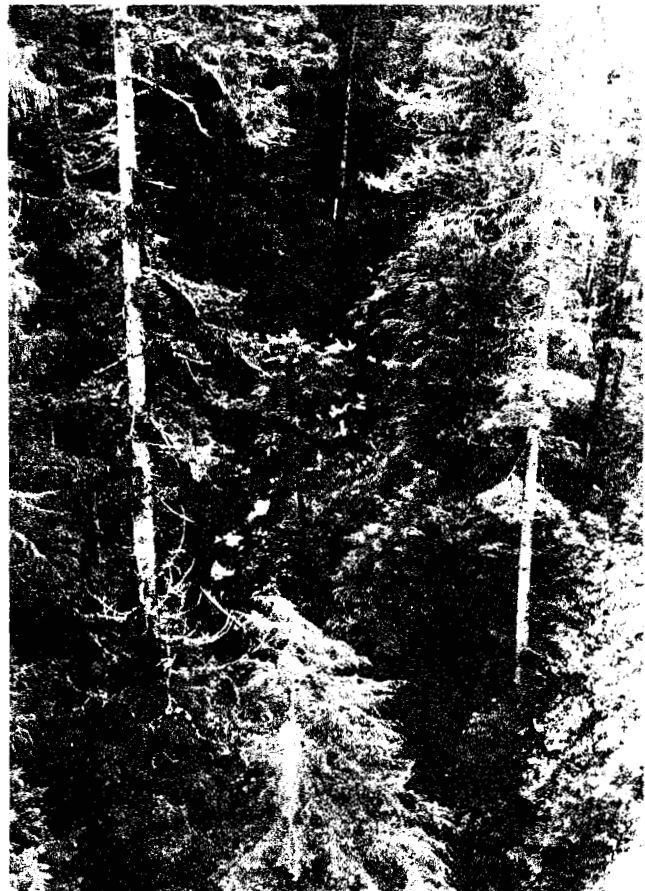
6. East Fork: Approximately 1200 m below lake, a steep bedrock/boulder channel represents a potential migratory impass.

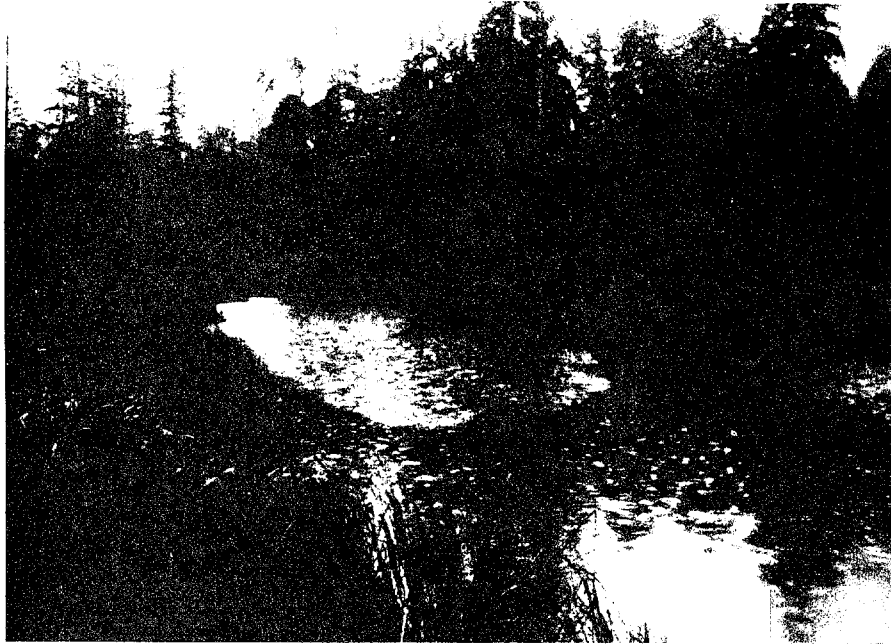
1. Area "F": Confluence of Area "F" and Red Lake. Beaver dams and "backed-up" flow result in extensive pooling. Note .5 x 15 m active beaver dam, center left.

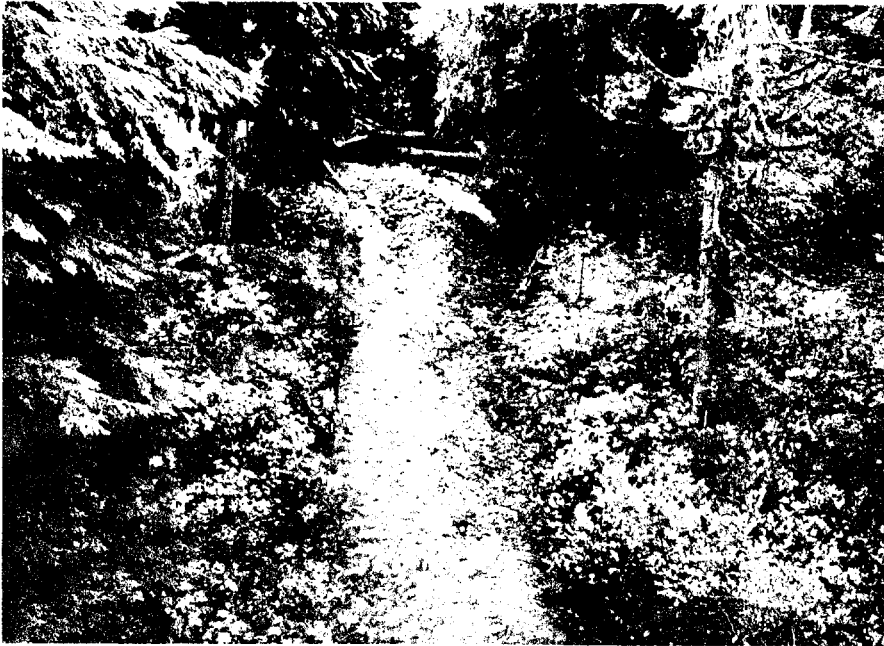
3. Section 9: Gradient and substrate size increasing, however, ASA remains common. A small, sinuous tributary enters the main stem, upper right.

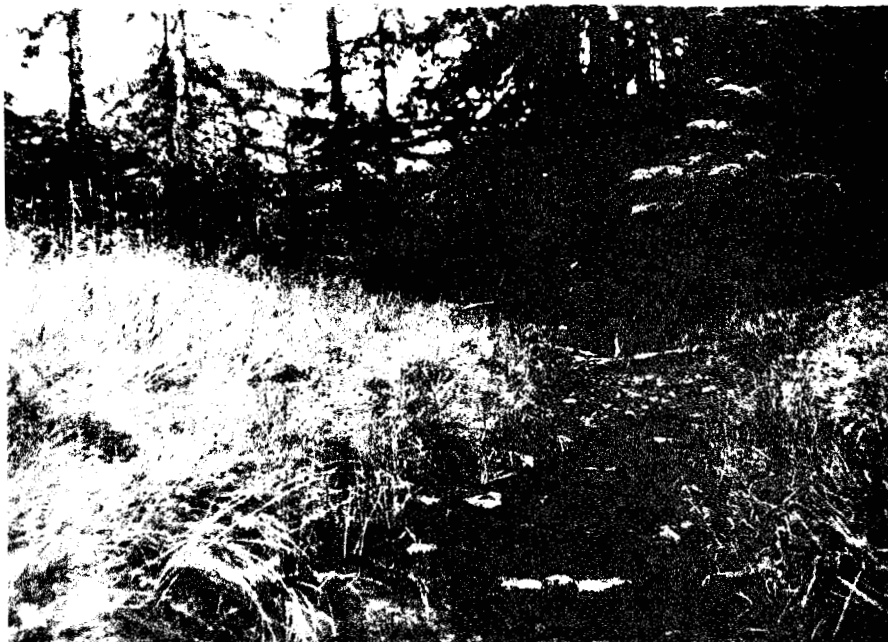
1. Intertidal Looking up Channel to Buffer Strip.  
No Appreciable Intertidal Spawning Potential.

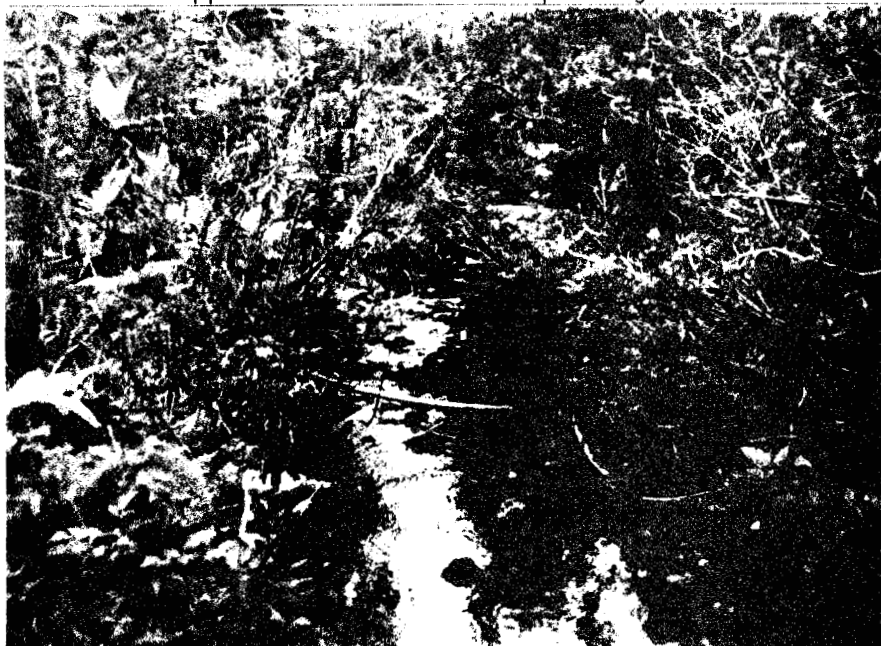
2. Section 2: Cobble Riffle Section; Patchy ASA.  
Heavy Brush Both Banks.

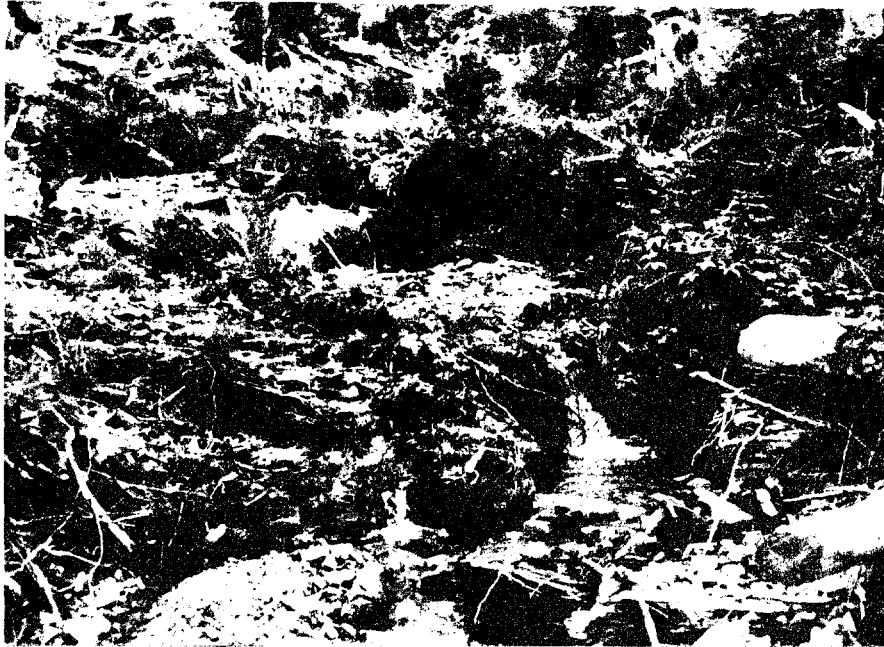
3. Section 3: Heavy Debris has Induced Frequent Channel Migration.

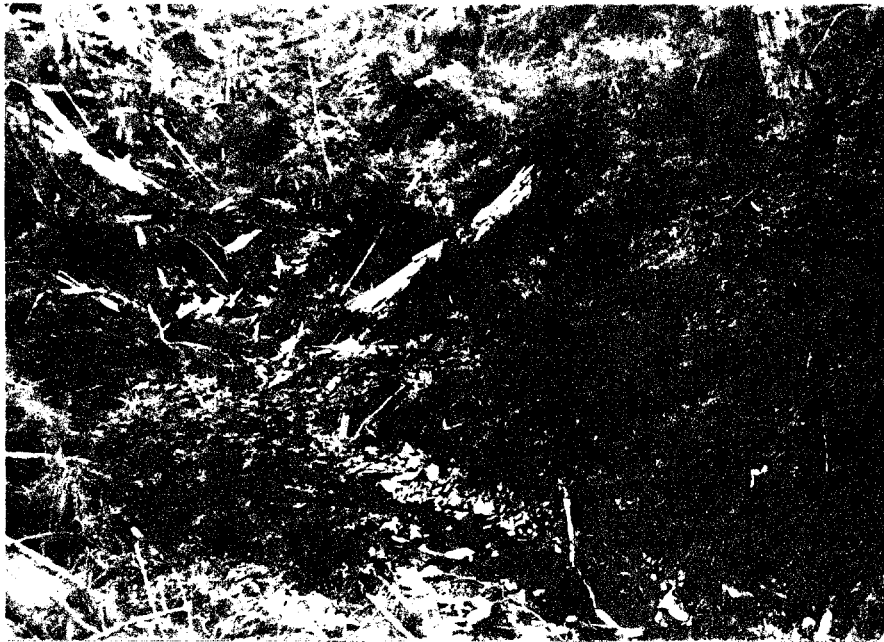
4. Looking Upstream Beyond End of Survey. Gradient Rapidly Increases, and Debris Loading Approaches 100%.

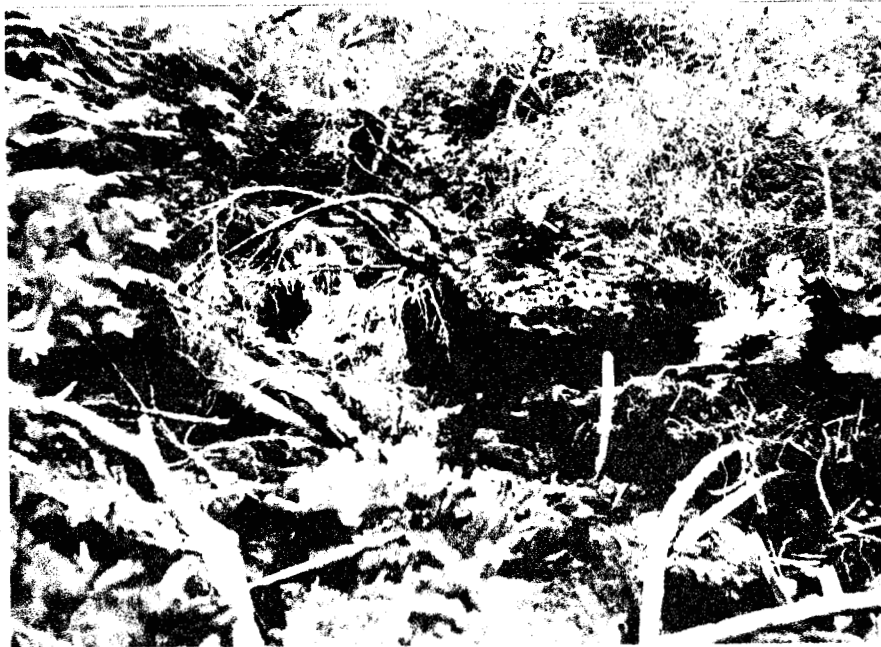
6. Left Fork Section 2: Steep Gradients  
Primarily Boulder/Bedrock Substrate, and  
Heavy Debris Loading. No Spawning or  
Rearing Potential.

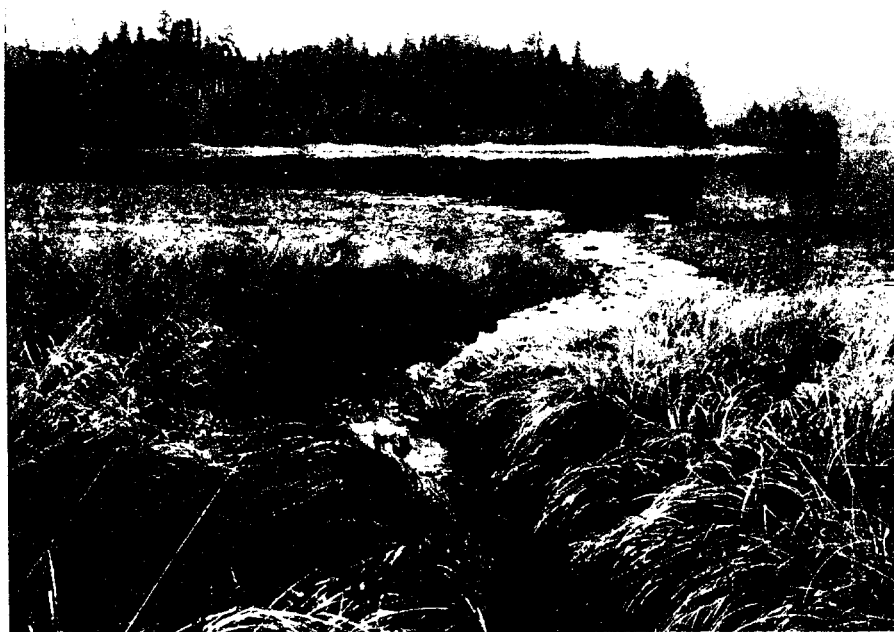
2. Intertidal Zone Looking West Over Red Bay.  
No Significant Intertidal ASA.

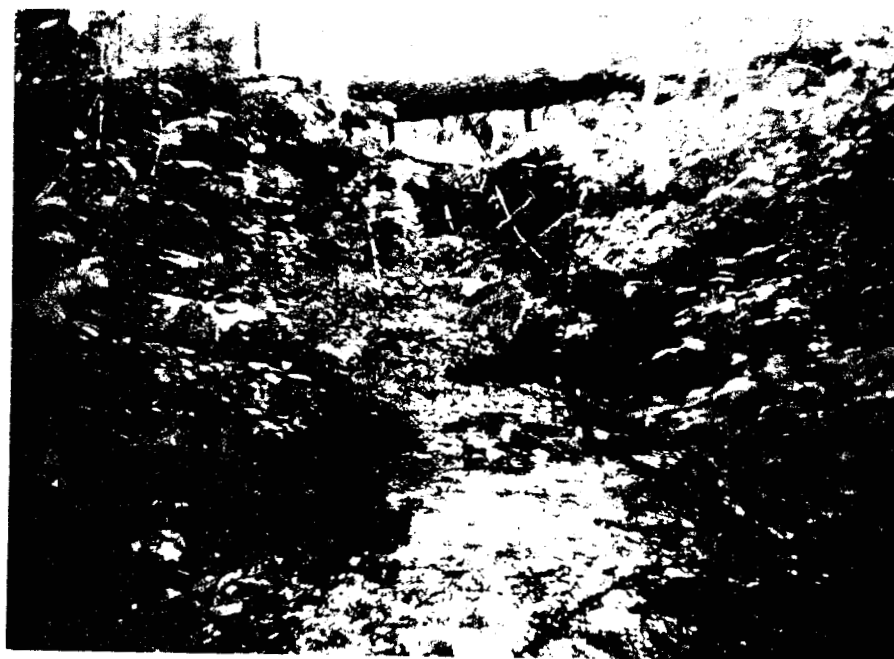
4. Creek No. 4 Looking Downstream Over Blowdown Along the Unit Boundary.

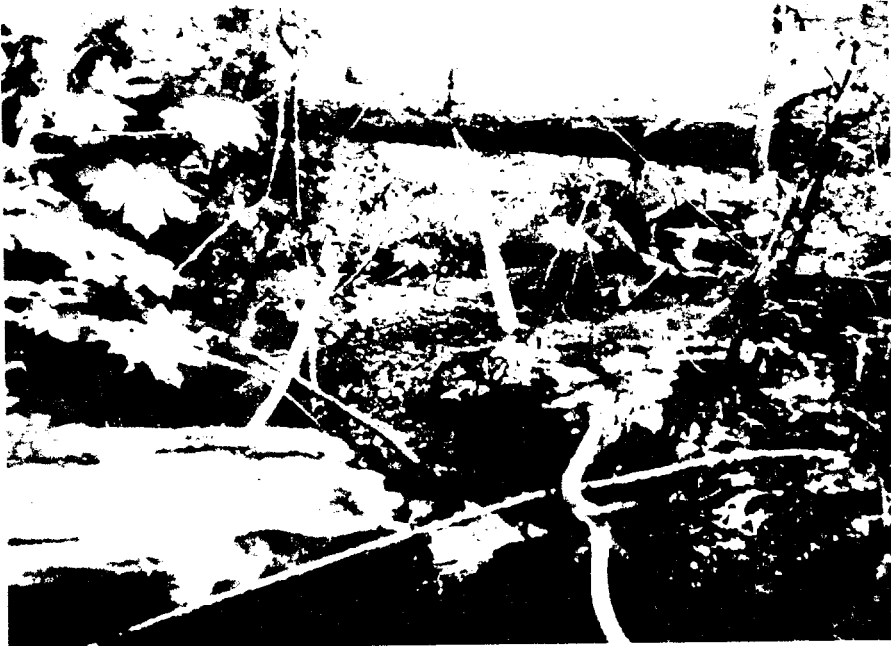
3. Section 1: Excellent Riffle/Pool Section. Portions of Right Bank Buffer Strip Have Blown Across Stream.

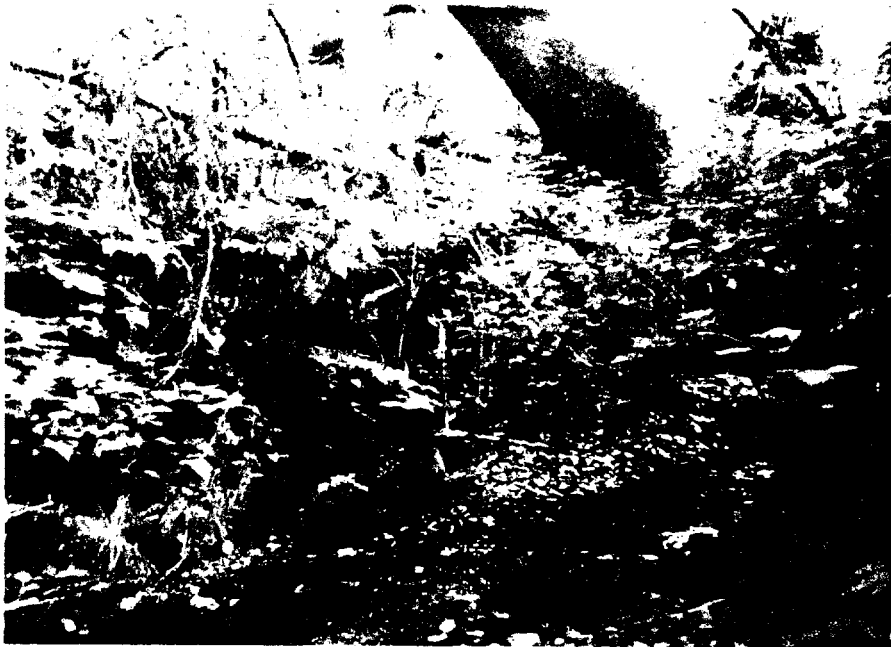
4. Section 2: The Bulk of the Right Bank Buffer Strip has Blown Across Channel.

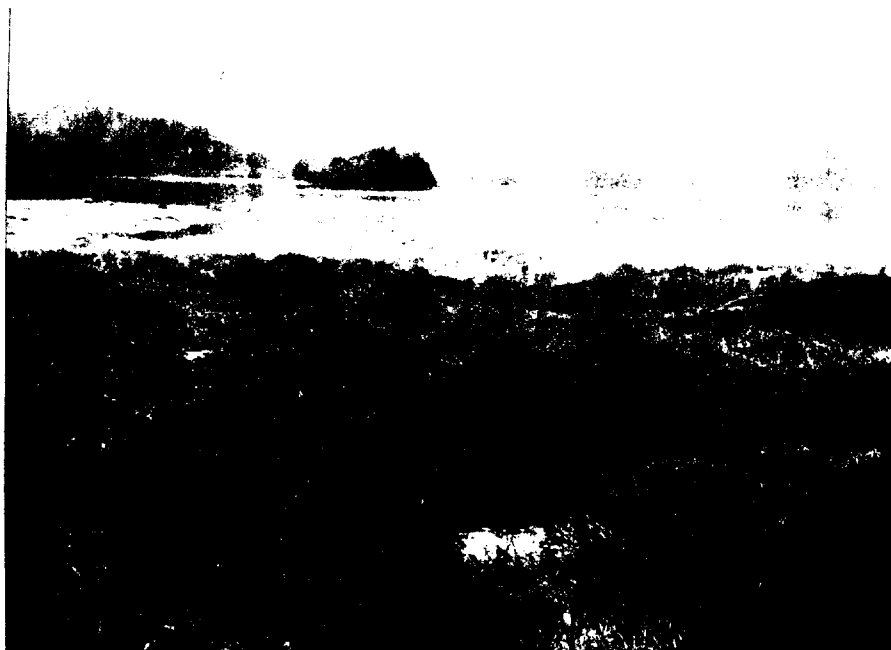
1. The ITZ Looking West Over Red Bay.

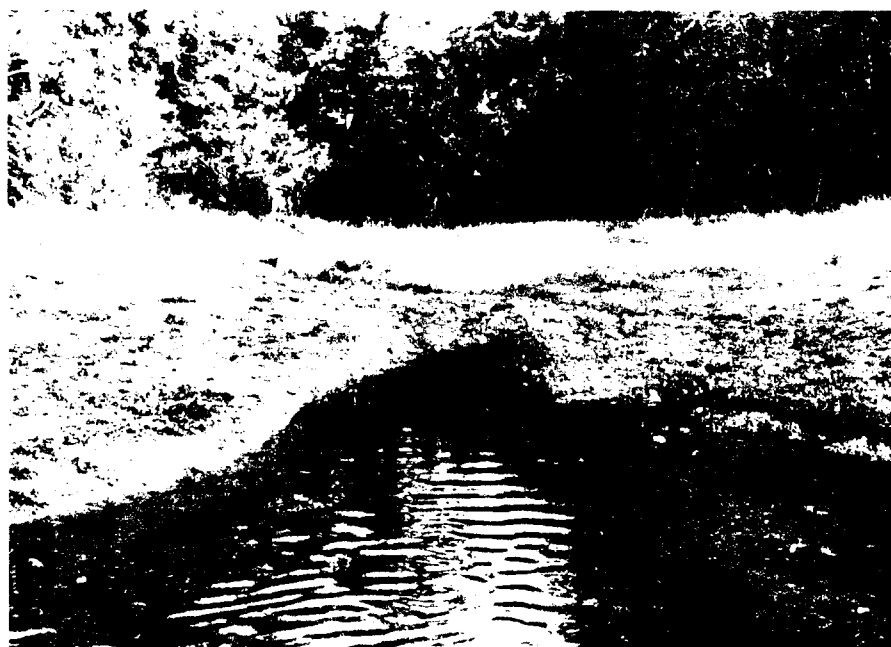
2. The ITZ Looking Toward the Creek Mouth.  
Intertidal ASA is Poor Due to a Large  
Percentage of Fine Substrate.

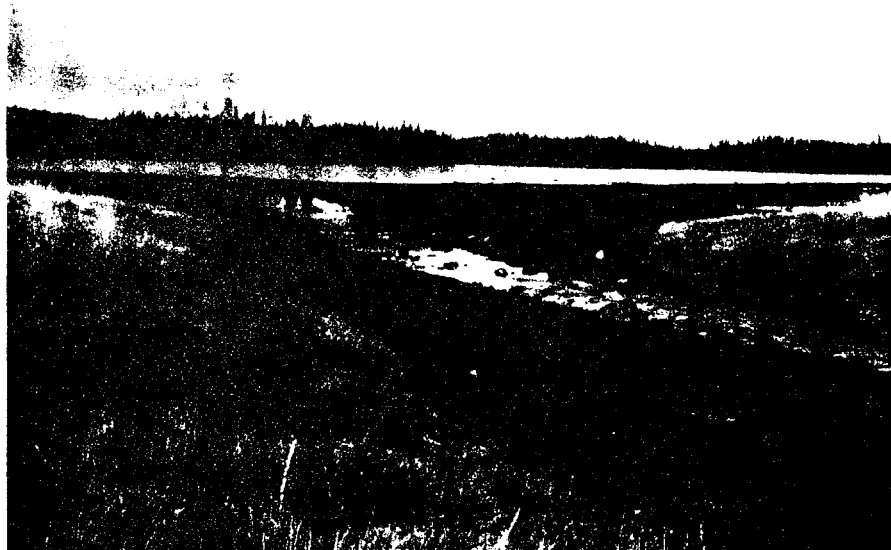
1. Downstream View of Lower ITZ, Looking West  
Toward Red Bay.

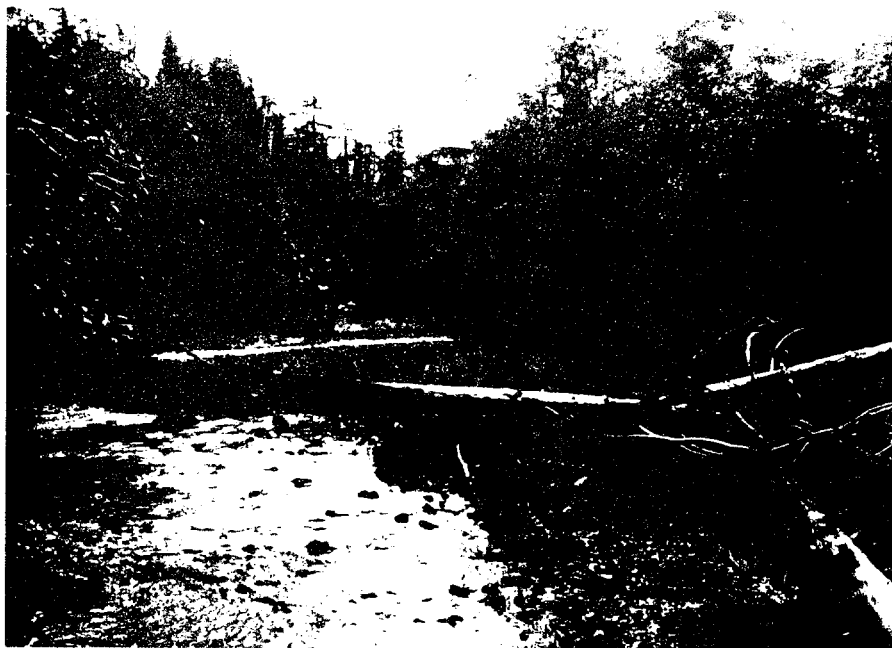
2. Upper ITZ and Mouth With Unit on Both Banks.

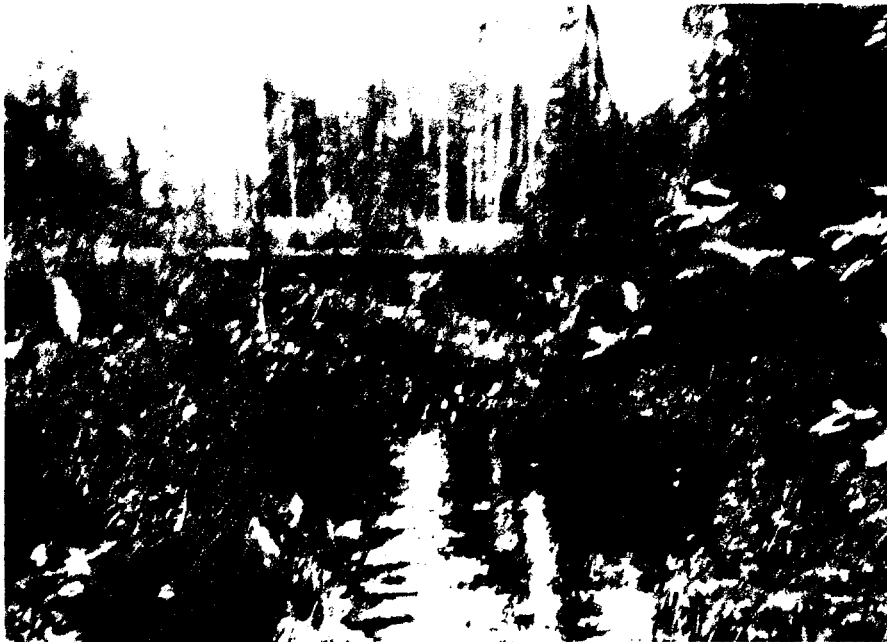
6. Beaver Dam and Pond/Marsh. End of Survey,  
Section 13: 46 m.

46m; Section and survey terminate at the base of a 1.3 meter high beaver dam in good repair. No fish were observed within the extensive impoundment.

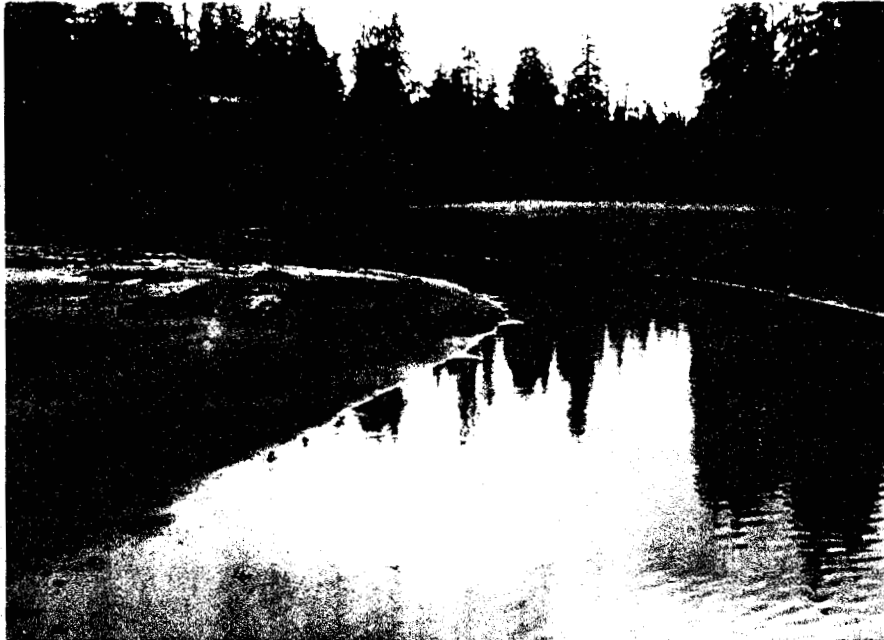
1. The ITZ Looking Toward the Stream Mouth.  
Intertidal ASA is Poor Due to Fine Substrate.

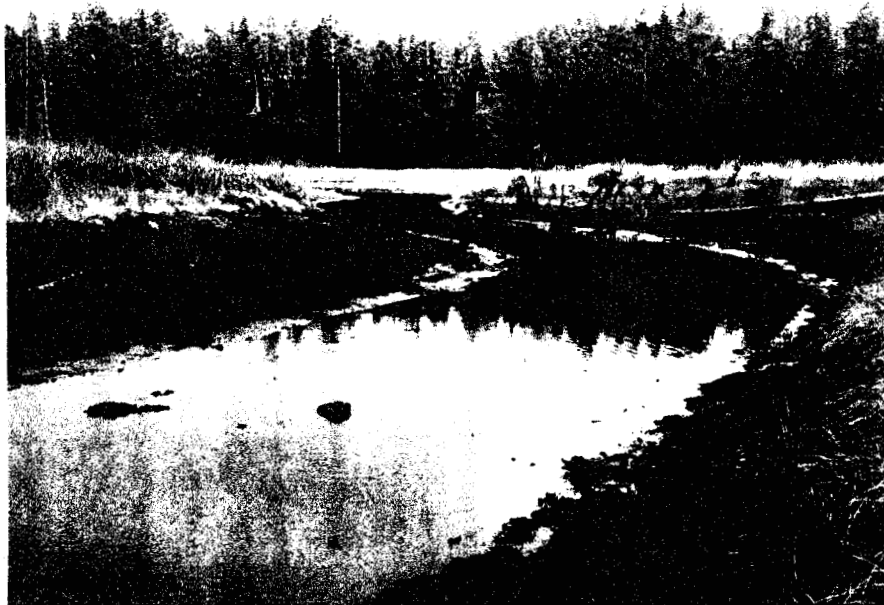
2. The ITZ Looking North Toward Bell Island. ASA  
is Poor Due to Low Flow.

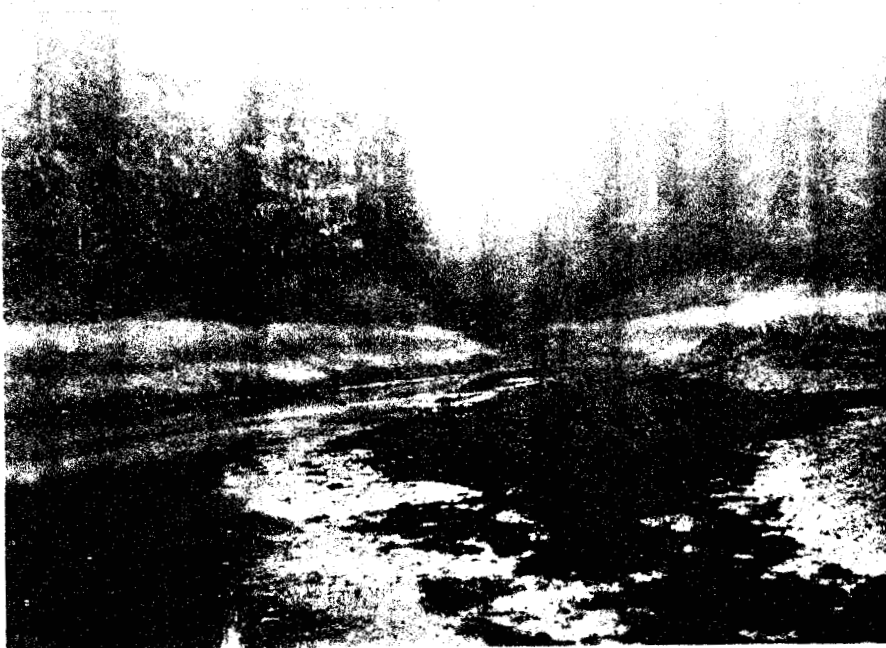
2. Upper Intertidal Zone Looking Upstream.
